LIMITED ASBESTOS SURVEY

**VACANT TENANT SPACE
1234 AMMI TRAIL
HOUSTON, HARRIS COUNTY, TEXAS**

TDS PROJECT NO. 10000

**RE: Limited Asbestos Survey
Vacant Tenant Space
1234 Ammi Trail
Houston, Harris County, Texas
TDS Project No. 10000**

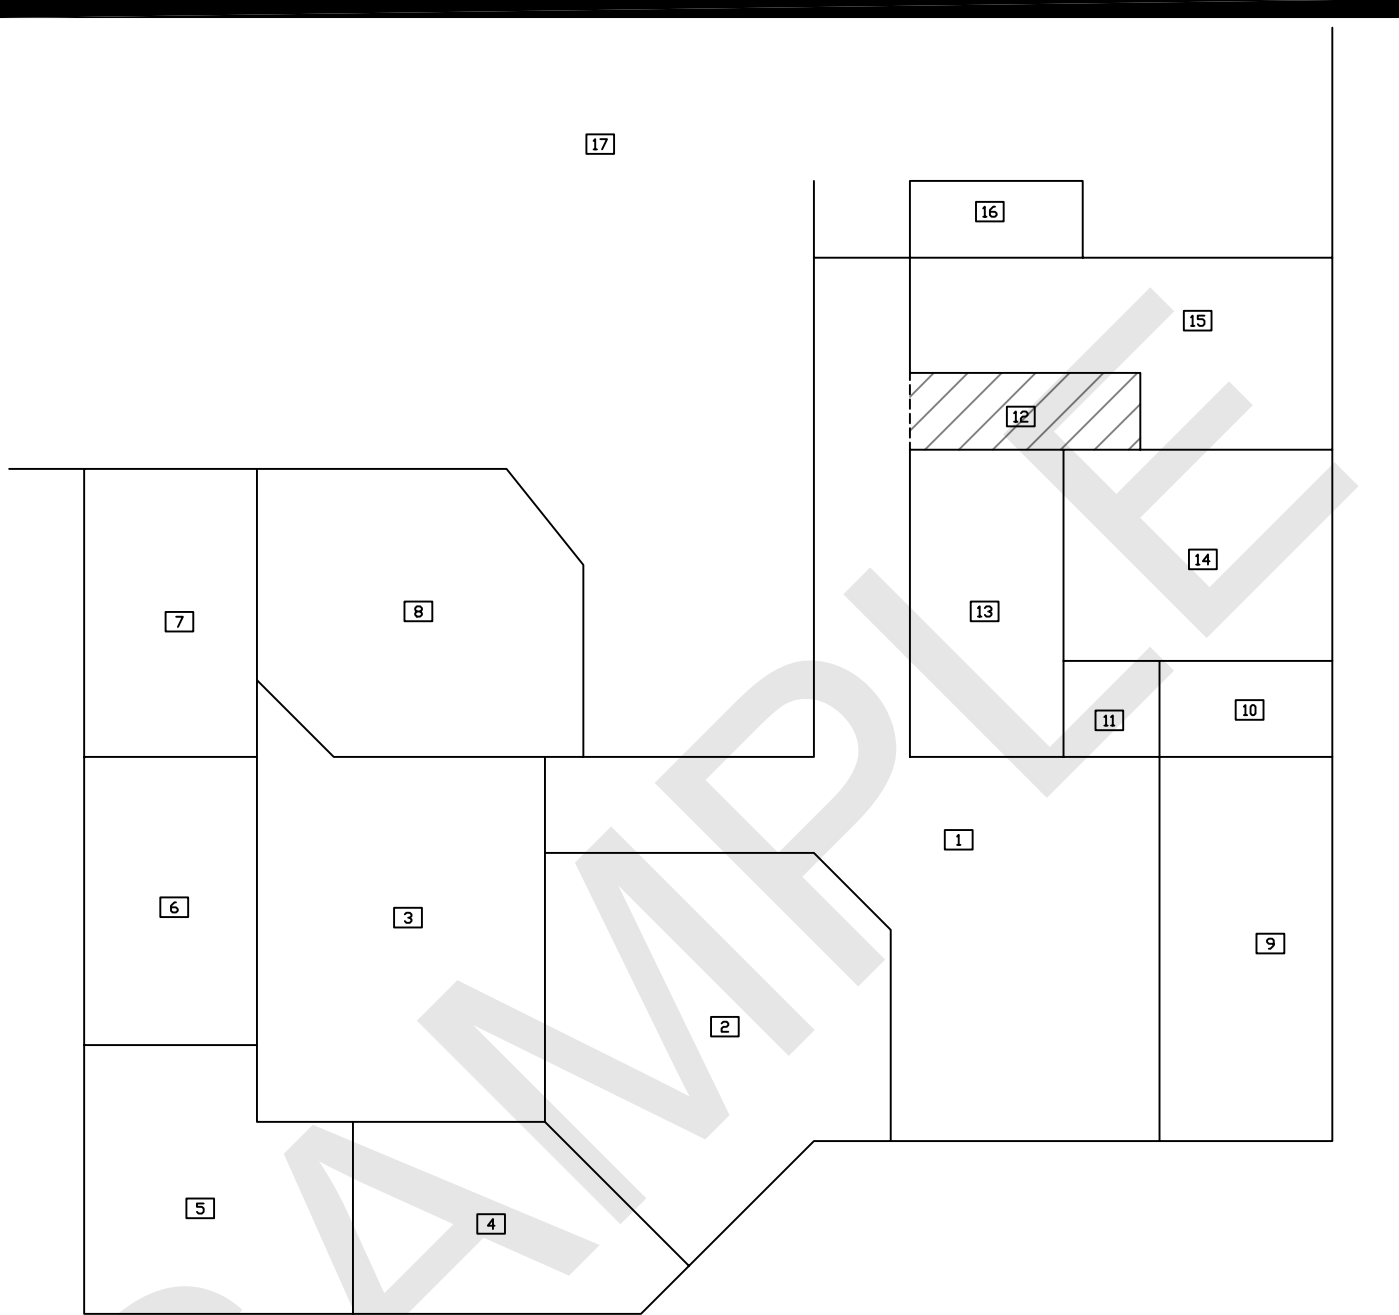
MATERIAL LOCATION DRAWING

- **Homogeneous Area (H.A.) #8 – Black and yellow floor mastic beneath carpet** (approximately 48 linear feet) located in Room 12 contained one to five percent chrysotile asbestos. This material was observed to be in good condition and non-friable. Based on the existing site operations, this material has a low potential for disturbance.

[Hatched Box] - ASBESTOS FLOOR MASTIC (BENEATH CARPET)

If the identified ACBM is not to be removed, then an Operations and Maintenance Program should be implemented to manage the ACBM in place and reduce exposure potential to tenants, occupants, and maintenance personnel.
