**LIMITED ASBESTOS SURVEY**

**NORTH AMERICAN INDUSTRIAL PLANT  
MAIN LABORATORY BUILDING (PARTIAL)  
1234 GOODYEAR BOULEVARD  
TEXAS CITY, GALVESTON COUNTY, TEXAS**

**TDS PROJECT NO. 10000**

**JANUARY 2010**

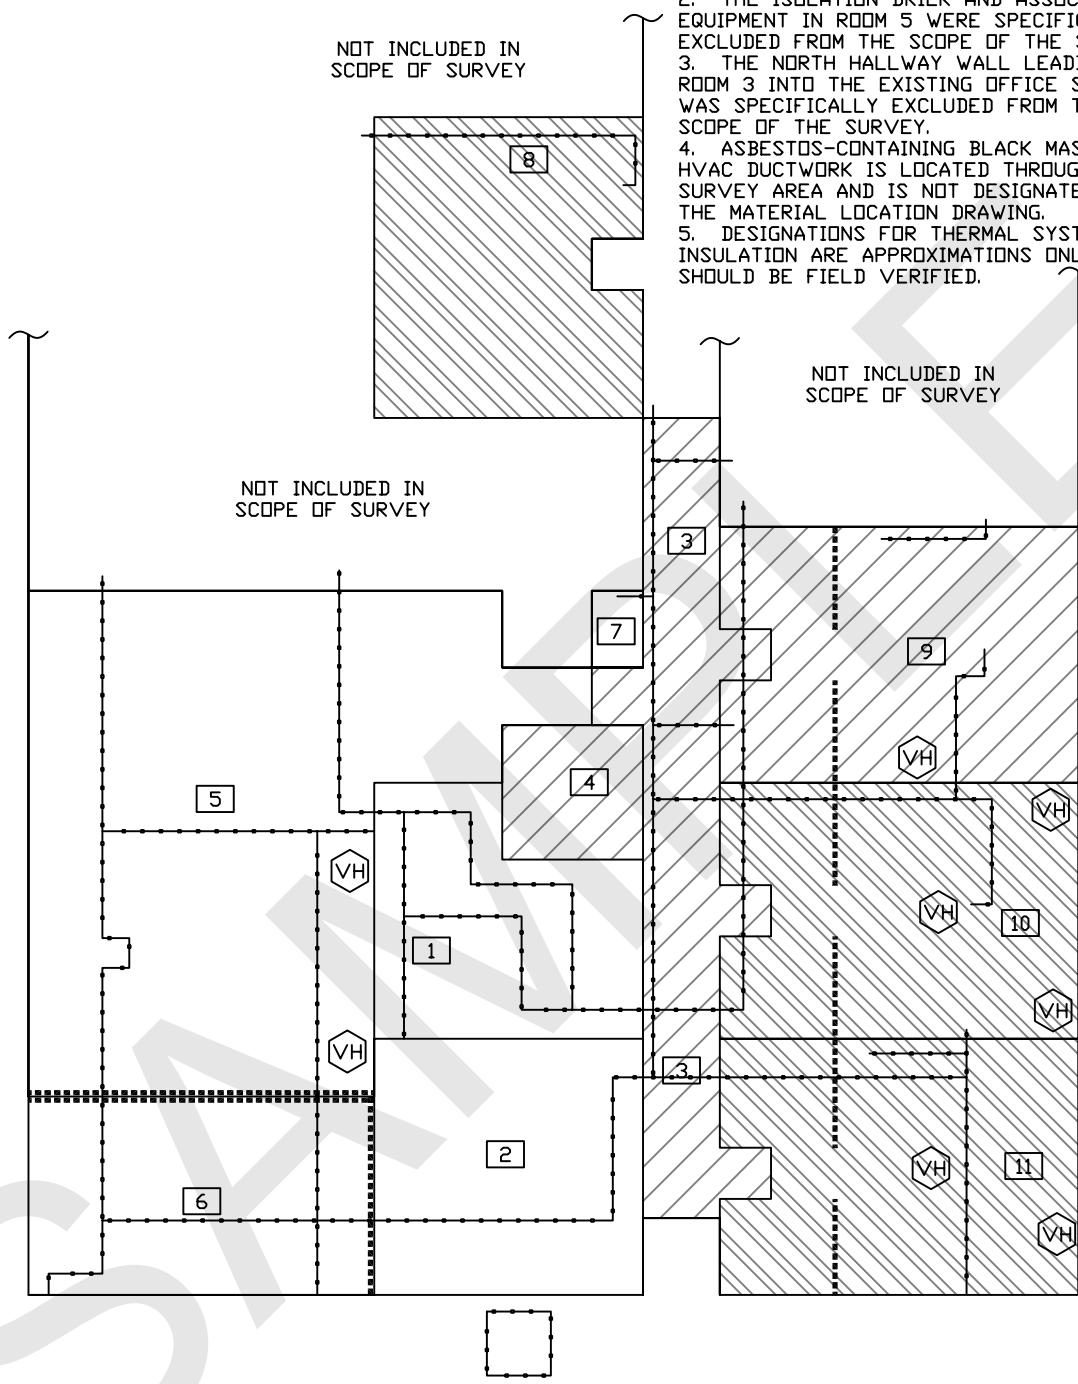
**MATERIAL LOCATION DRAWING**  
 NORTH AMERICA INDUSTRIAL PLANT  
 MAIN LABORATORY BUILDING (PARTIAL)  
 1234 GOODYEAR BOULEVARD  
 TEXAS CITY, GALVESTON COUNTY, TEXAS

- **Homogeneous Area (H.A.) #2 – Paper and black mastic cover associated with abandoned chilled water pipe fitting insulation** (approximately 70 fittings) located in Rooms 1, 3, 5, 9, 10, and south exterior (loose) contained 10 to 12 percent chrysotile asbestos. This material was observed to be in good condition and friable.

- **H.A. #3 – Hard fibrous abandoned hot water pipe run insulation** (approximately 210 linear feet) located in Rooms 1, 3, 9, and 10 contained two to four percent chrysotile asbestos. This material was observed to be in good condition and friable.

- **H.A. #7 – Black mastic on fiberglass duct insulation** (approximately 513 linear feet or 4,232 square feet) located in Rooms 1, 2, 3, 4, 5, 7, 8, 9, 10, and 11 contained 14 percent chrysotile asbestos. This material was observed to be in good condition and non-friable.

- **H.A. #9 – Paper and white mastic cover associated with abandoned domestic cold/hot water and steam lines (run)** (approximately 1,008 linear feet) located in Rooms 2, 3, 5, 6, 7, 8, 9, 10, and 11 contained a trace (less than one percent) to six percent chrysotile asbestos. This material was observed to be friable and have localized damage.

- **H.A. #10 – Hard fibrous insulation on abandoned domestic cold/hot water and steam lines (fitting)** (approximately 140 fittings) located in Rooms 2, 3, 5, 6, 7, 8, 9, 10, and 11 contained three to five percent chrysotile asbestos. This material was observed to be friable and have localized damage.

- **H.A. #11 – 12” x 12” cream floor tile with beige and white speckles and black mastic** (approximately 1,100 square feet) located in Rooms 3, 4, and 9 contained 10 percent chrysotile asbestos in the tile and five percent chrysotile asbestos in the mastic. This material was observed to be in good condition and non-friable.

- **H.A. #13 – Hard, gray cementitious vent hood walls** (approximately eight vent hoods) located in Rooms 5, 9, 10, and 11 contained 16 percent chrysotile asbestos. This material was observed to be in good condition and non-friable.

- **H.A. #14 – Hard, gray cementitious wallboard** (approximately 912 square feet) located in Rooms 5 and 6 contained 20 percent chrysotile asbestos. This material was observed to be in good condition and non-friable.

- **H.A. #15 – Thermal system pipe run insulation associated with isolation drier** (approximately 60 linear feet) located in Room 5 was not sampled. This material should be assumed to be asbestos-containing unless proper sampling and analysis proves otherwise. This material was observed to be in good condition and friable.

- **H.A. #16 – Thermal system pipe fitting insulation associated with isolation drier** (approximately 8 fittings) located in Room 5 was not sampled. This material should be assumed to be asbestos-containing unless proper sampling and analysis proves otherwise. This material was observed to be in good condition and friable.

- **H.A. #17 – Black and tan mastic associated with 12” x 12” gray floor tile** (approximately 924 square feet) located in Rooms 8 and 10 contained three to four chrysotile asbestos in the mastic. No asbestos was identified in the associated floor tile; however, the floor tile should be treated as asbestos-contaminated. This material was observed to be in good condition and non-friable.

- **H.A. #18 – Black and yellow mastic associated with 12” x 12” blue floor tile** (approximately 98 square feet) located in Room 8 contained three to four chrysotile asbestos in the mastic. No asbestos was identified in the associated floor tile; however, the floor tile should be treated as asbestos-contaminated. This material was observed to be in good condition and non-friable.

- **H.A. #22 – Hard cementitious wallboard at lab area entry** (approximately 216 square feet) located in Rooms 9, 10, and 11 contained 20 percent chrysotile asbestos. This material was observed to be in good condition and non-friable.

- **H.A. #24 – Black and yellow mastic associated with 12” x 12” beige floor tile** (approximately 544 square feet) located in Room 11 contained two to five chrysotile asbestos in the mastic. No asbestos was identified in the associated floor tile; however, the floor tile should be treated as asbestos-contaminated. This material was observed to be in good condition and non-friable.

The sampling, removal, clean up, maintenance and disposal of ACM should be conducted in accordance with applicable federal, state, and local regulations. Asbestos abatement actions should be performed by a qualified asbestos contractor. Air monitoring also provides critical documentation for the building owner and should be provided by qualified asbestos personnel.

If the identified ACM is not to be removed, then an Operations and Maintenance Program should be implemented to manage the ACM in place and reduce exposure potential to tenants, occupants, and maintenance personnel.
